Action B3 Test series of molds, cores and casts produced by
inorganic binder systems

DeB3 Quality analyses of test casts carried out in pilot foundries
in Green Foundry LIFE project

1. Introduction

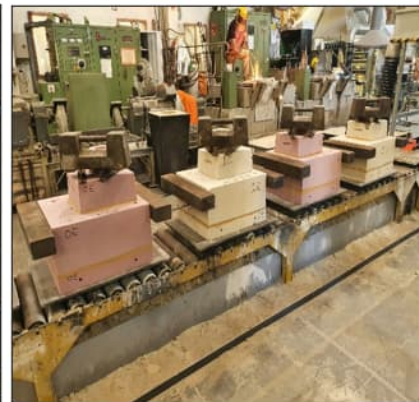
Mould preparation before

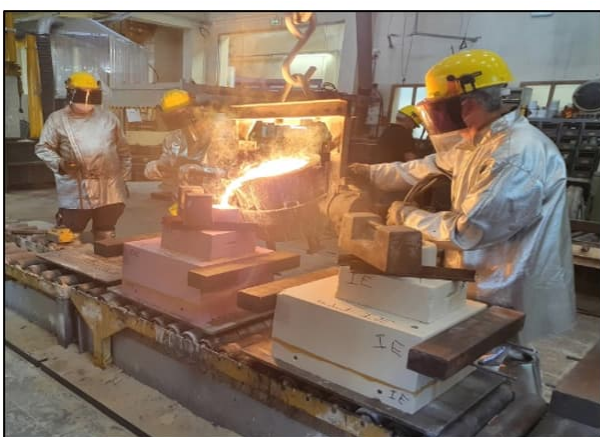
Steel GS240 pouring (30 kg/mould – casting weight = 12 kg)

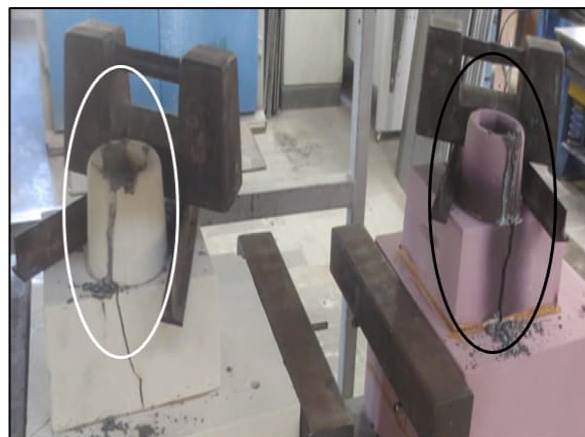
Inorganic sand ref. « I » Organic sand ref. 0 »

Metal/Sand ratio as a function of the casting thickness: from 4 to 0.20.

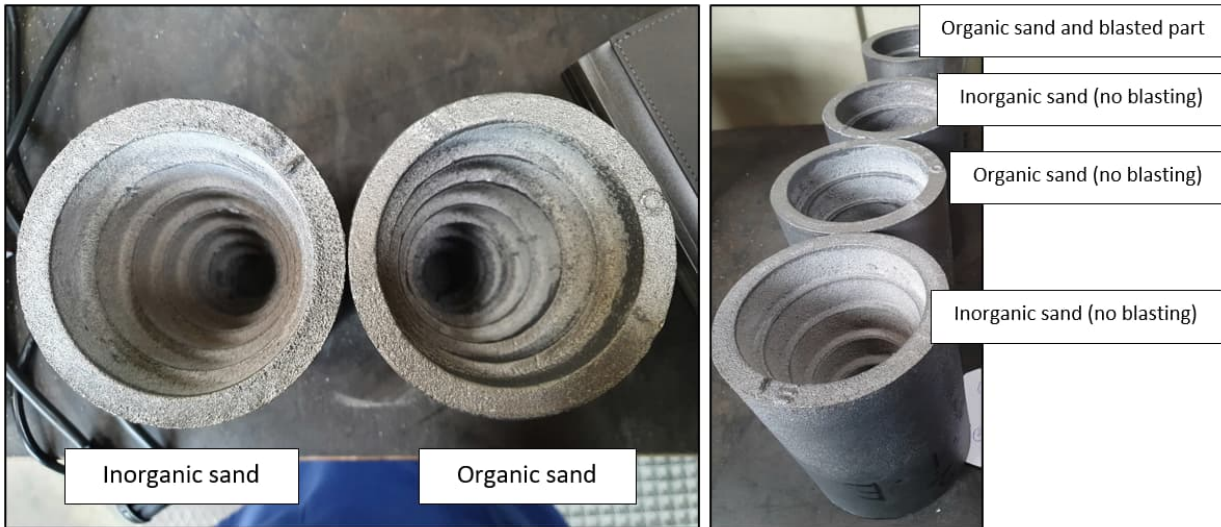
CTIF's shaken-out castings

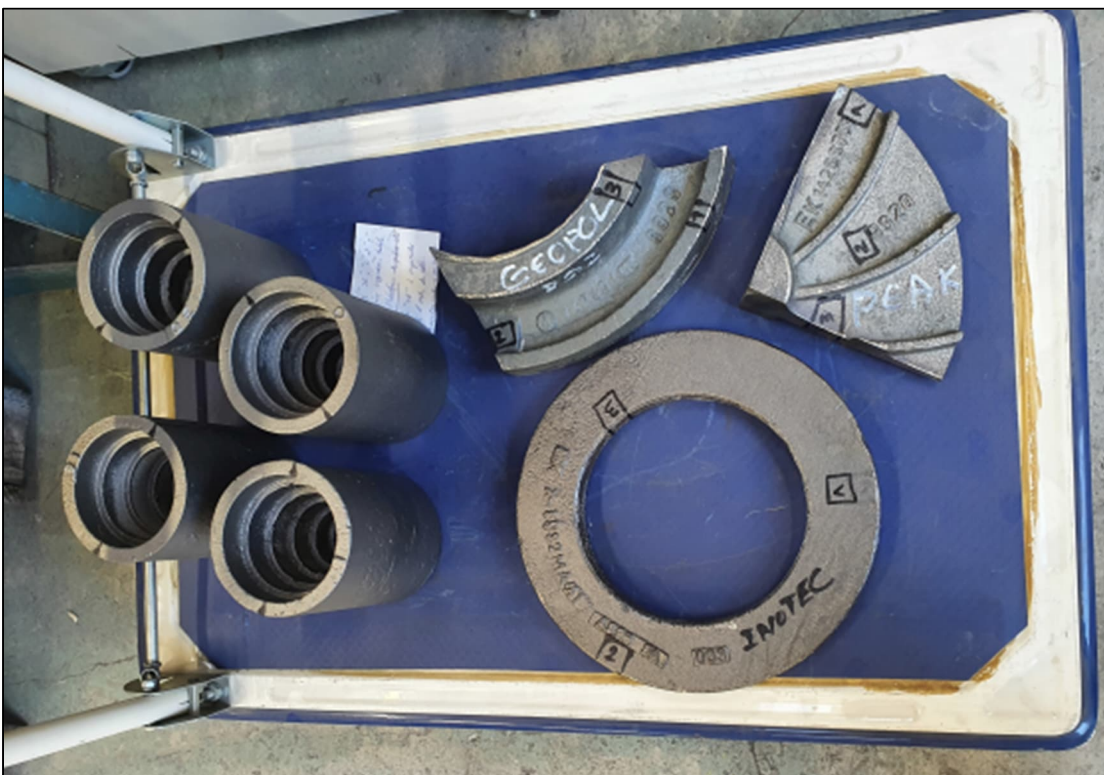
Parts cast by the different partners of the project

CTIF : Casting made of structural steel standard EN GS240,

INOTEC : Casting made of stainless steel ASTM A747 Cb7-Cu2 (Unified Numbering System 324 J92110),

GEOPEL and PEAK : Castings made of stainless steel ASTM A297 HH (UNS 401 J93503).

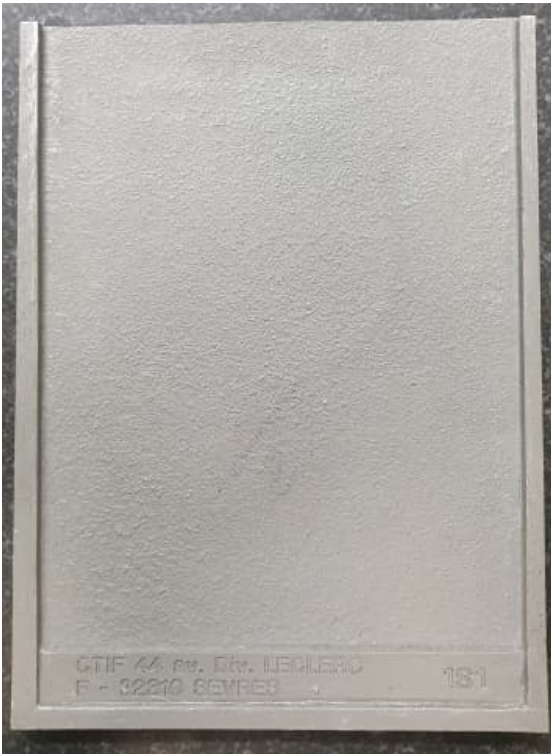
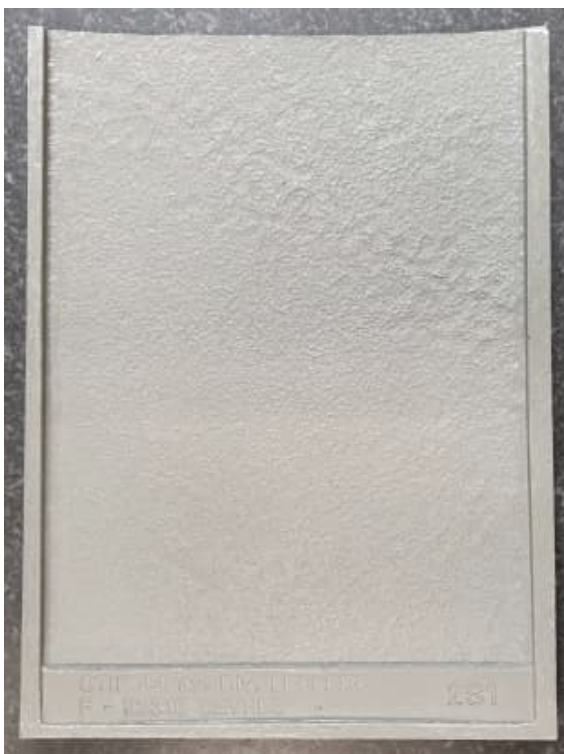
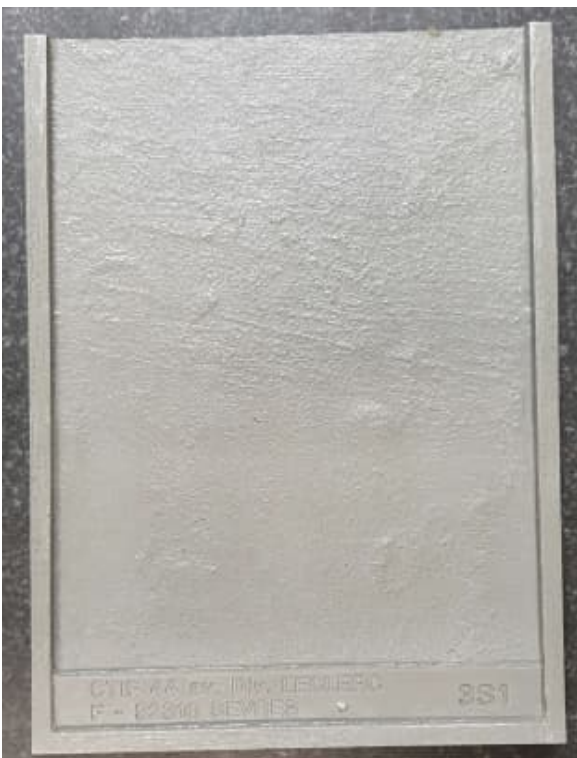
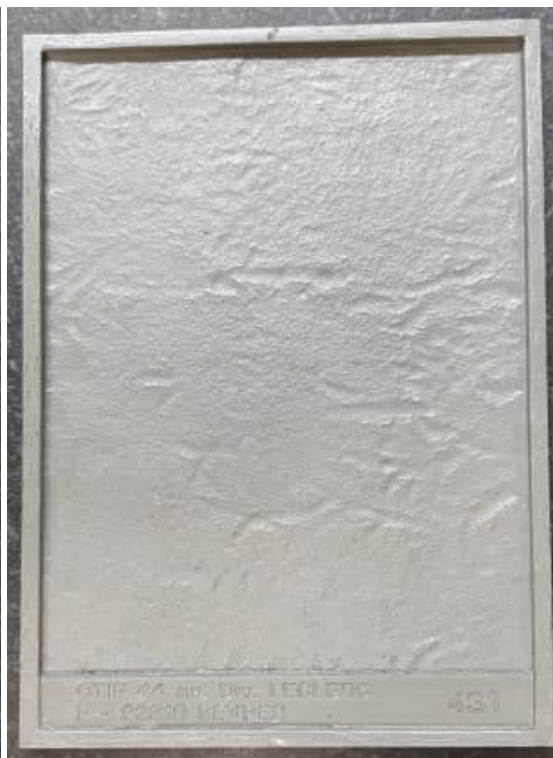
Characterization of the surface condition of steel parts: eight tactile visual comparators used, corresponding to the green sand molding and cold setting molding processes (plates 1S1 to 8S1)

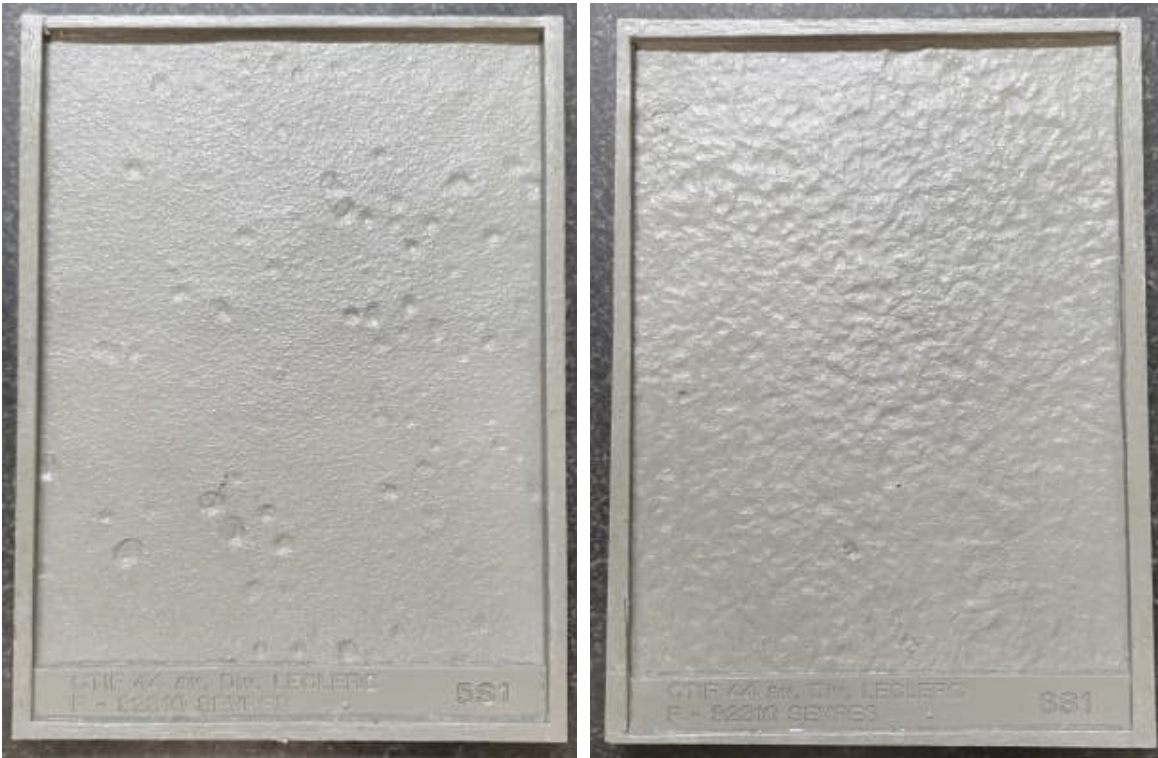
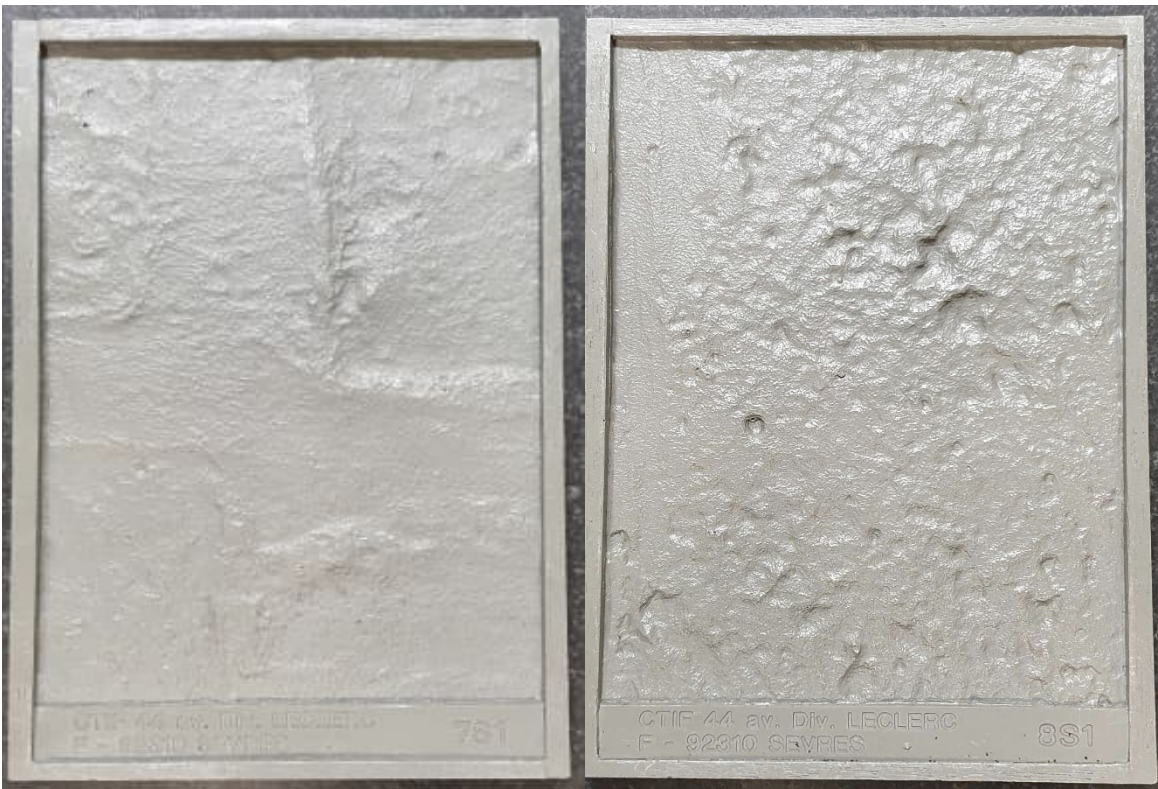
Characterization of the surface condition of steel parts: eight tactile visual comparators used, corresponding to the green sand molding and cold-setting molding processes (1S1 to 8S1) cont'd

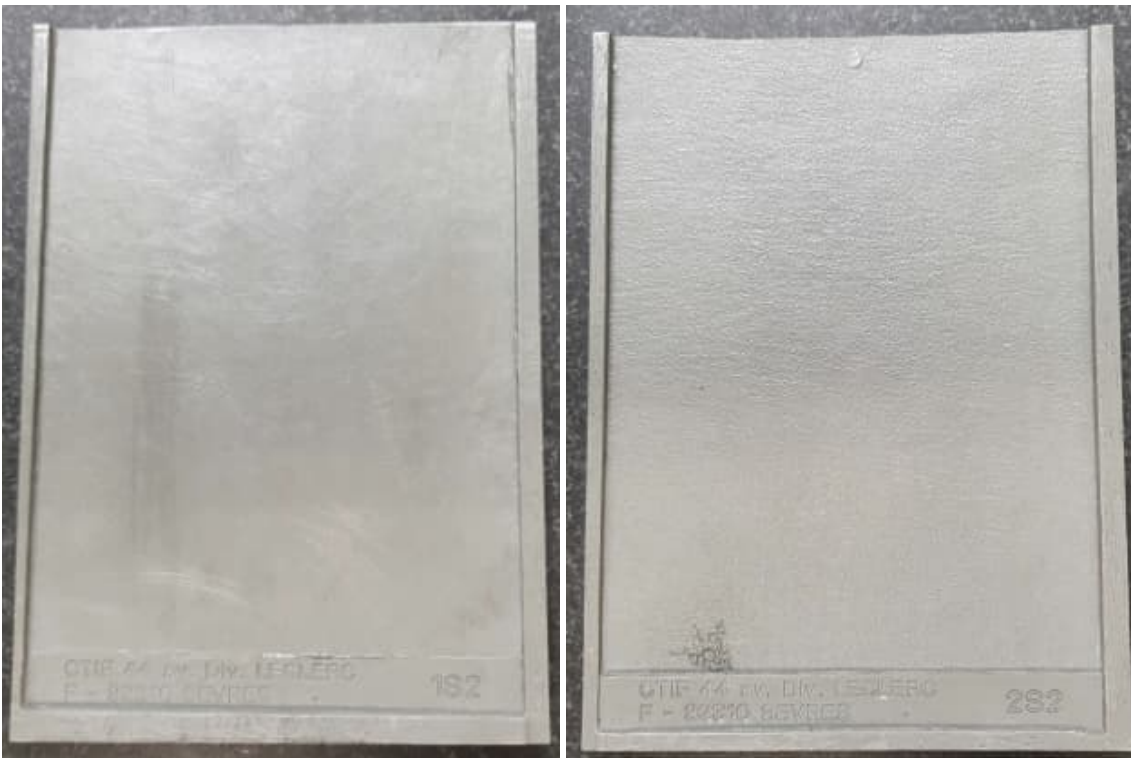
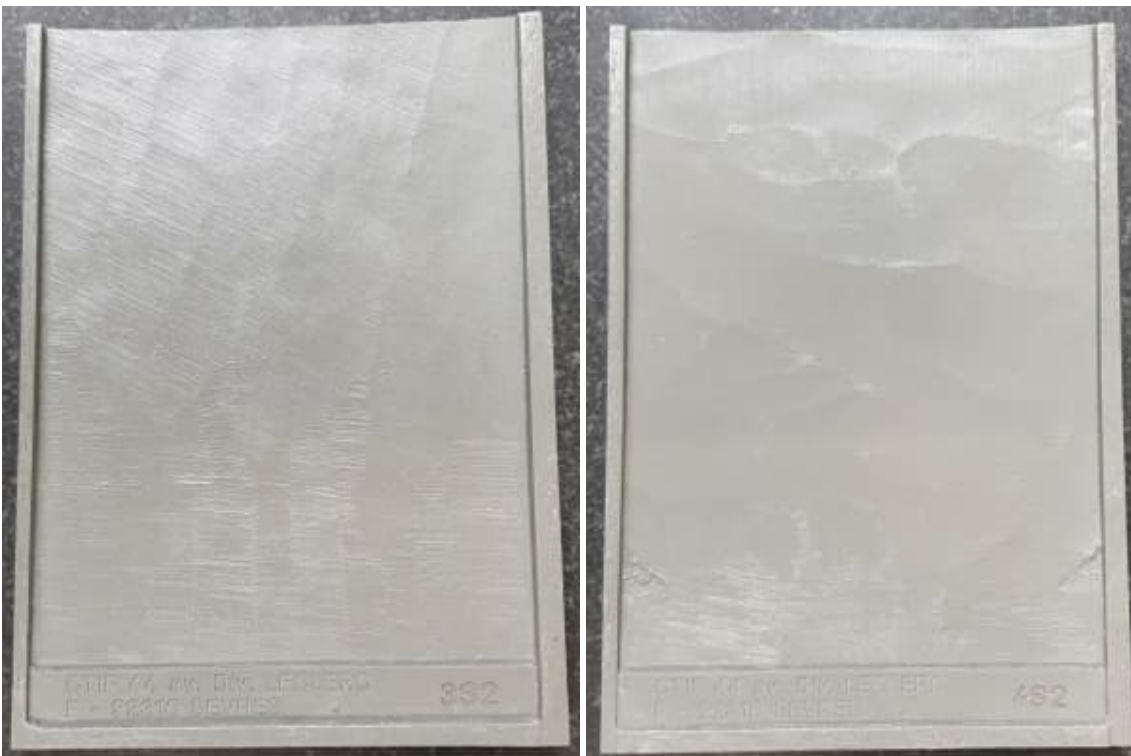
Characterization of the surface condition of steel parts: five tactile visual comparators used, corresponding to the finishing of parts by grinding, or grinding and shot blasting (1S2 to 5S2).

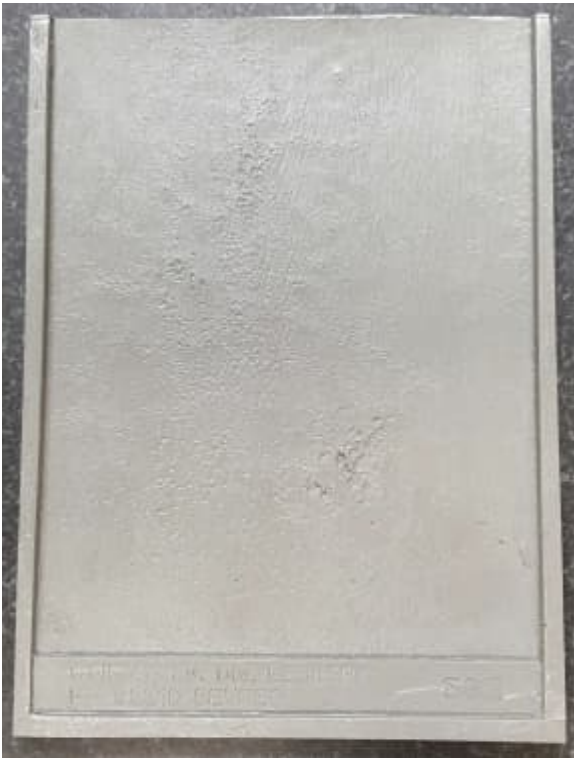
Characterization of the surface condition of steel parts: five tactile visual comparators used, corresponding to the finishing of parts by grinding or grinding and shot blasting (1S2-5S2) cont'd

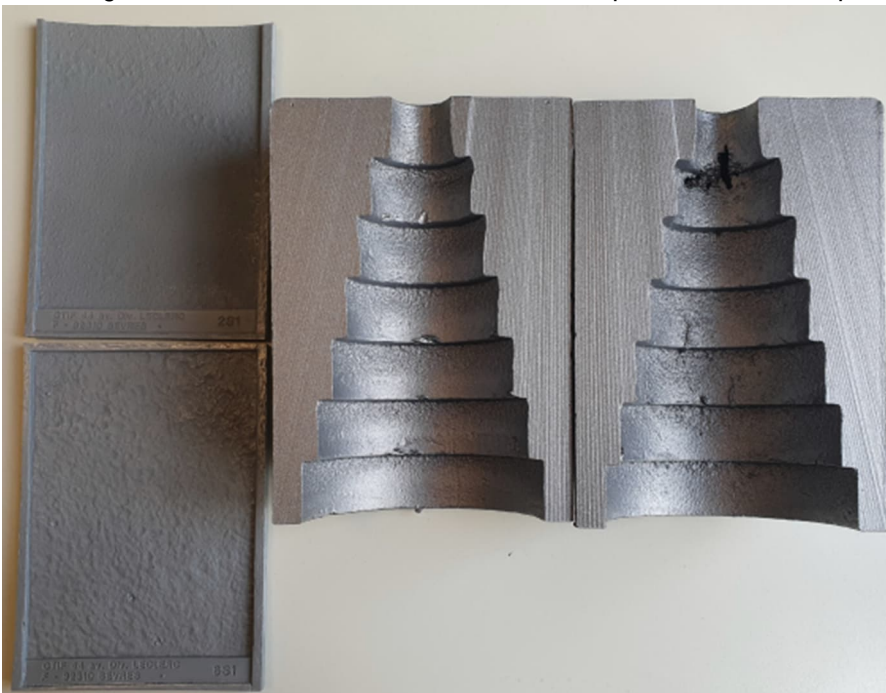
Check performed on the CTIF's part labelled I:

The roughness index of the surfaces inside the part varies corresponds to plates 2S1 to 6S1

Note: parts are not ground, surfaces are just sand-blasted.

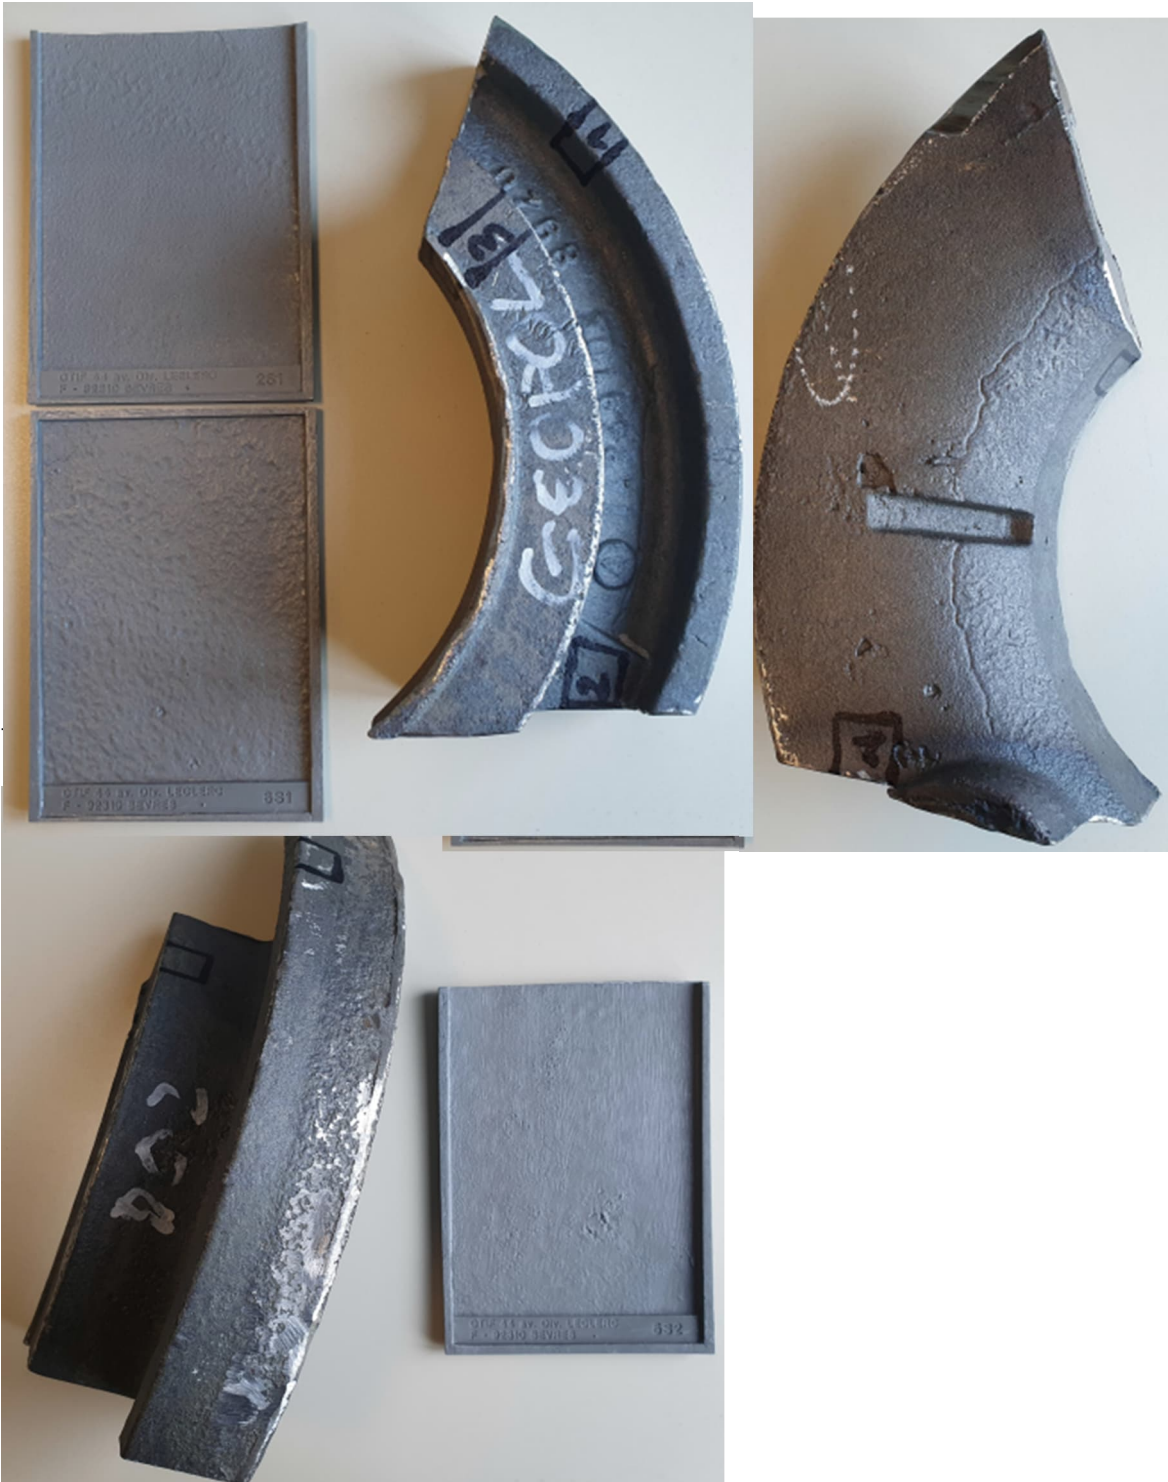
Check performed on the GEOPOL's part :

The roughness index of moulding surfaces varies and corresponds to plates 2S1 to 6S1

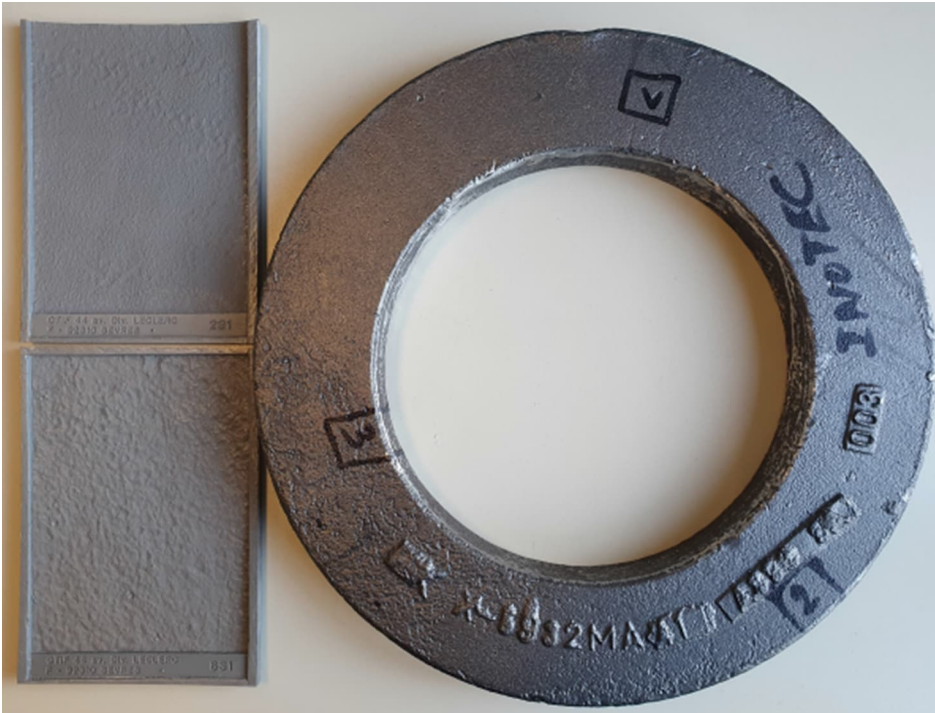
Check performed on the INOTEC's part :

The roughness index of moulding surfaces varies and corresponds to plates 2S1 to 6S1

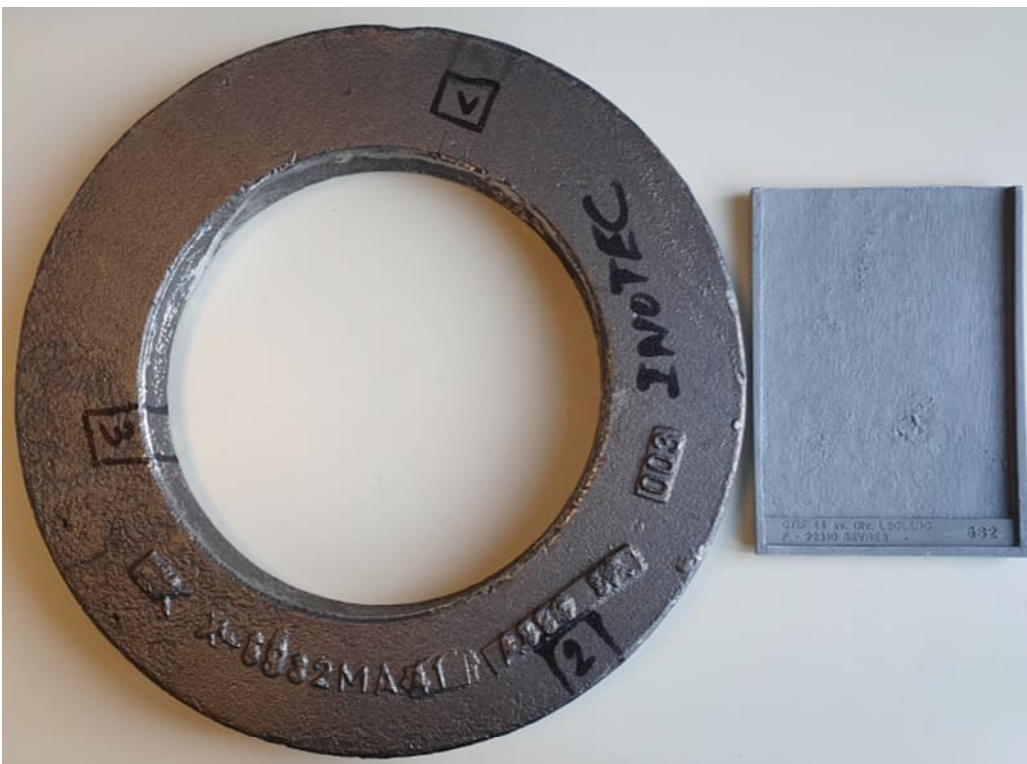
The average roughness index of the finishing surfaces corresponds to plate 5S2

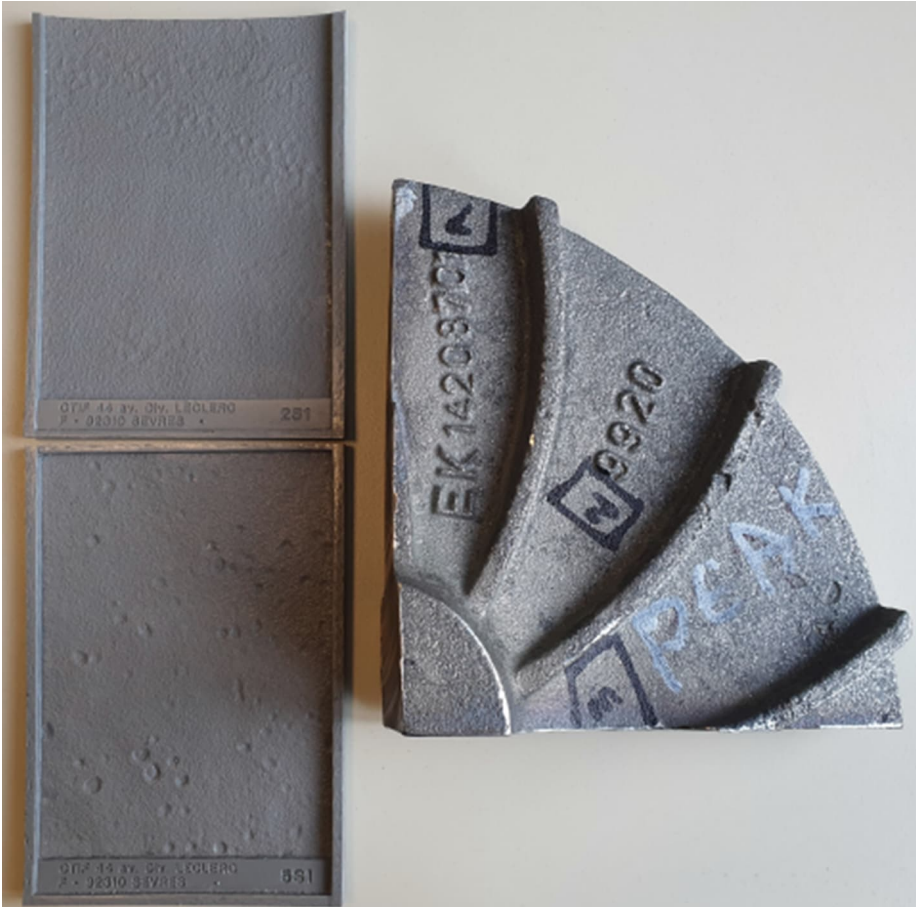
Check performed on the PEAK's part :

The roughness index of moulding surfaces varies and corresponds to plates 2S1 to 5S1

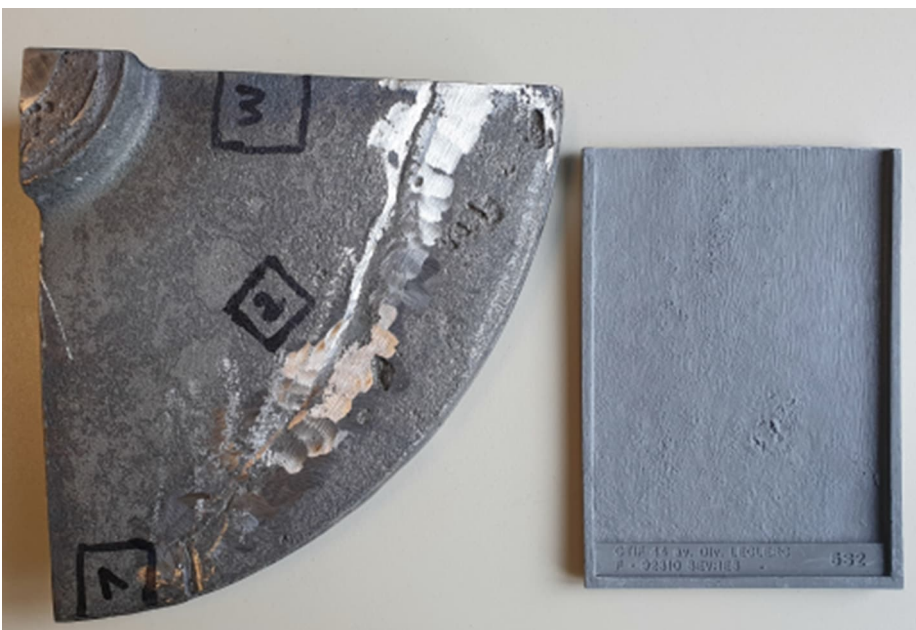
The average roughness index of the finishing surfaces corresponds to plate 5S2

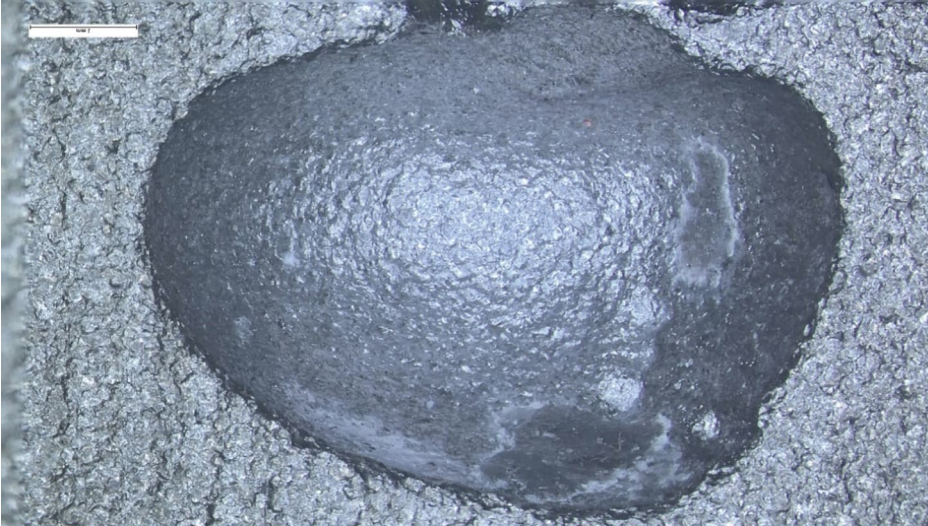
Photo O - 03 bino 7-1

Blowhole trapped in the part and located at the top of the mould (size 10 x 8 mm)

These defects are not attributable to the organic binder, they are mainly due to a turbulent pouring system and poor degassing of the mould in the upper part.

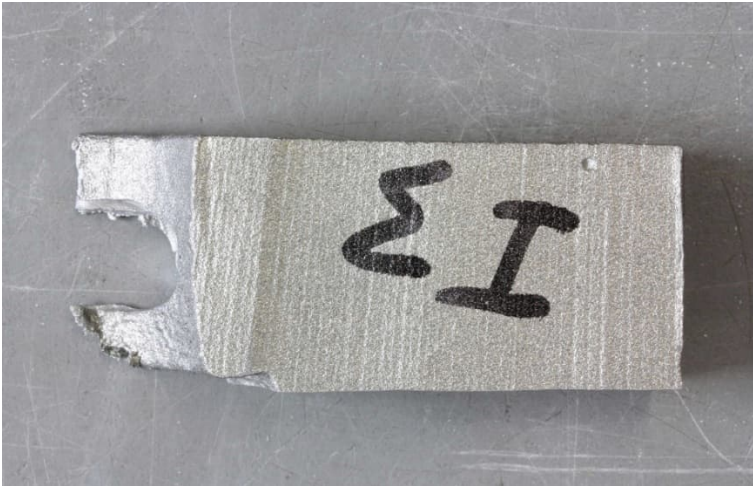
Photo I 3-6

Pinhole trapped in the part and located at the top of the mould (diameter ≈ 1 mm)

These defects are not attributable to the inorganic binder, they are mainly due to oxide inclusion due to dross settling and turbulent cavity filling (fall casting system).

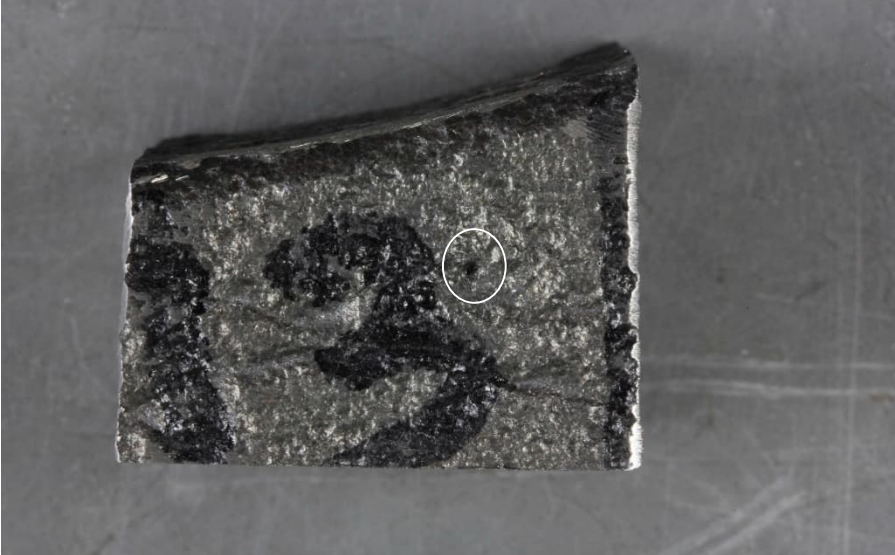
Photo Inotec 3-1

Cavity identified at the surface (diameter \approx 1 mm)

This defect is probably not attributable to the inorganic binder, it is a sand inclusion: a metal penetration defect is visible at the surface of the inotec part, close to the above inclusion defect (see page 14 for the position of the sample "Inotec 3" in relation to the metal penetration defect).
