Action B4.5 Treatment tests of inorganic sand waste

DeB4.5 Feasibility studies of the reuse of inorganic surplus foundry sand in core making and geo-construction

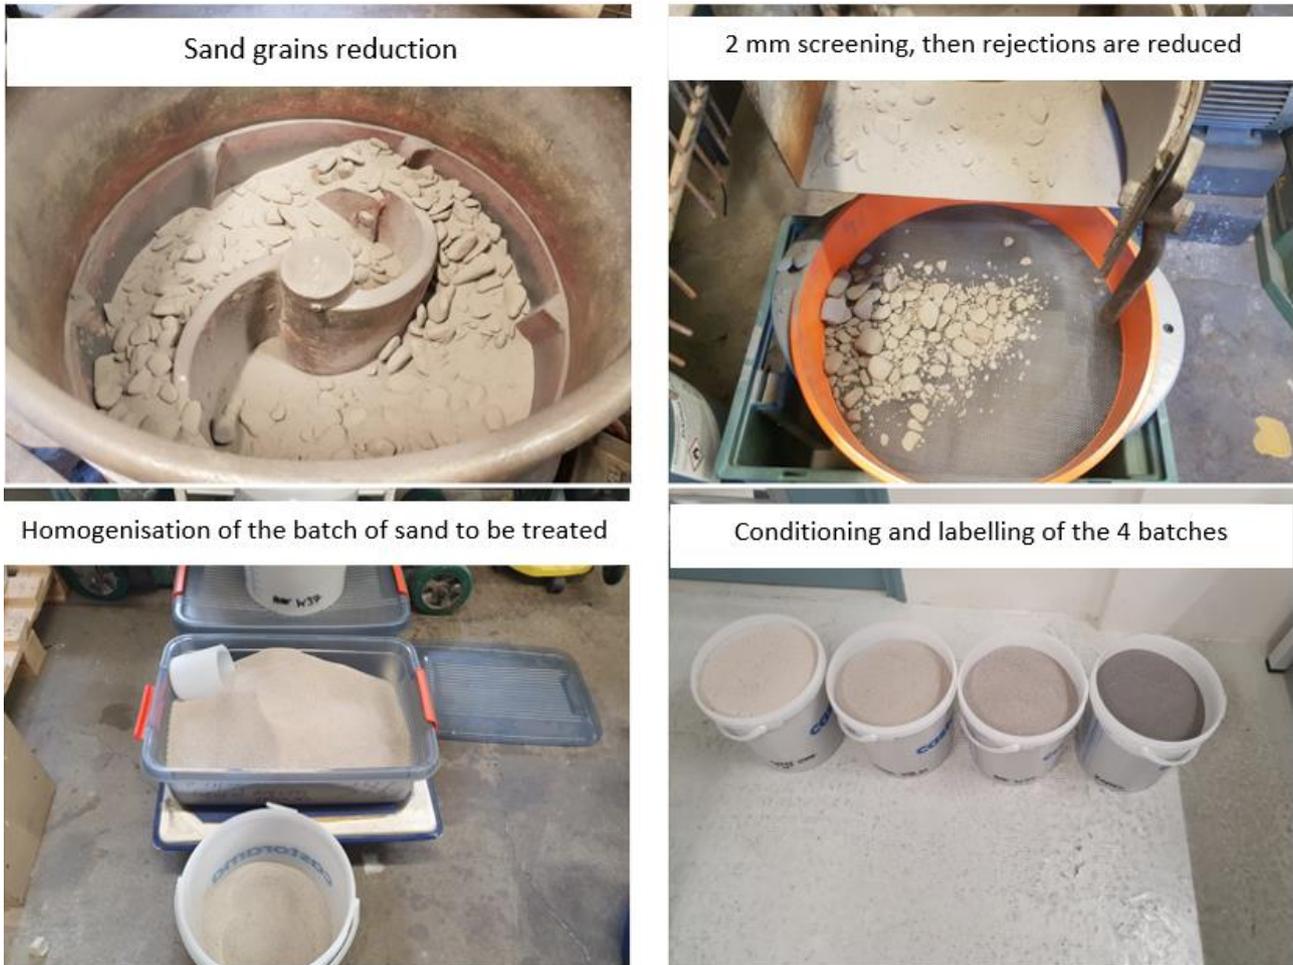
Illustration of the pre-treatment of sand waste to be treated

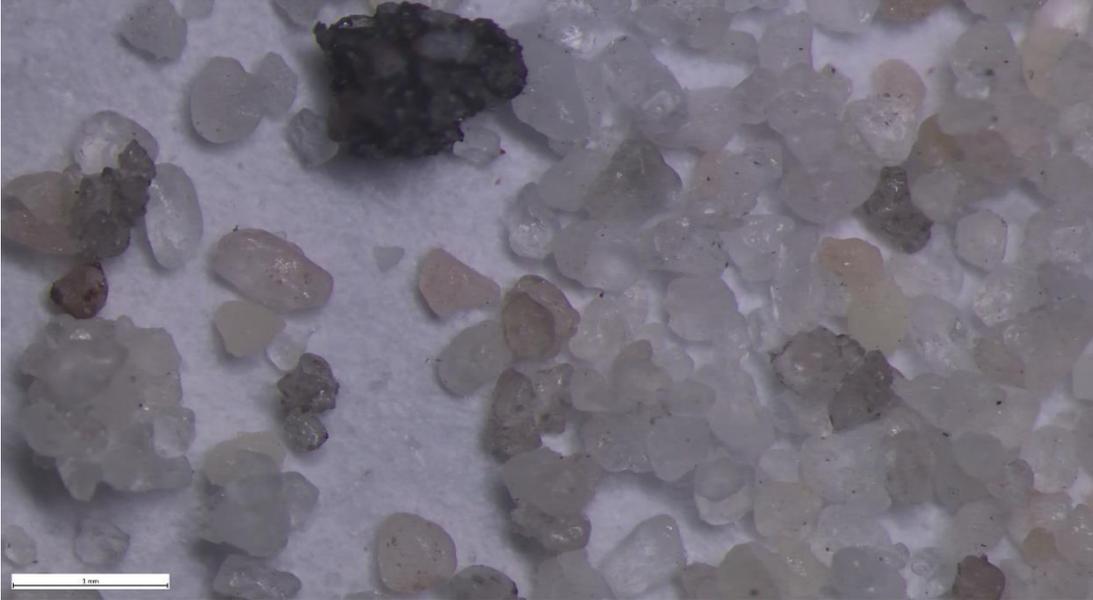
Photo optical microscope CTIF's sand IE to be treated: overview

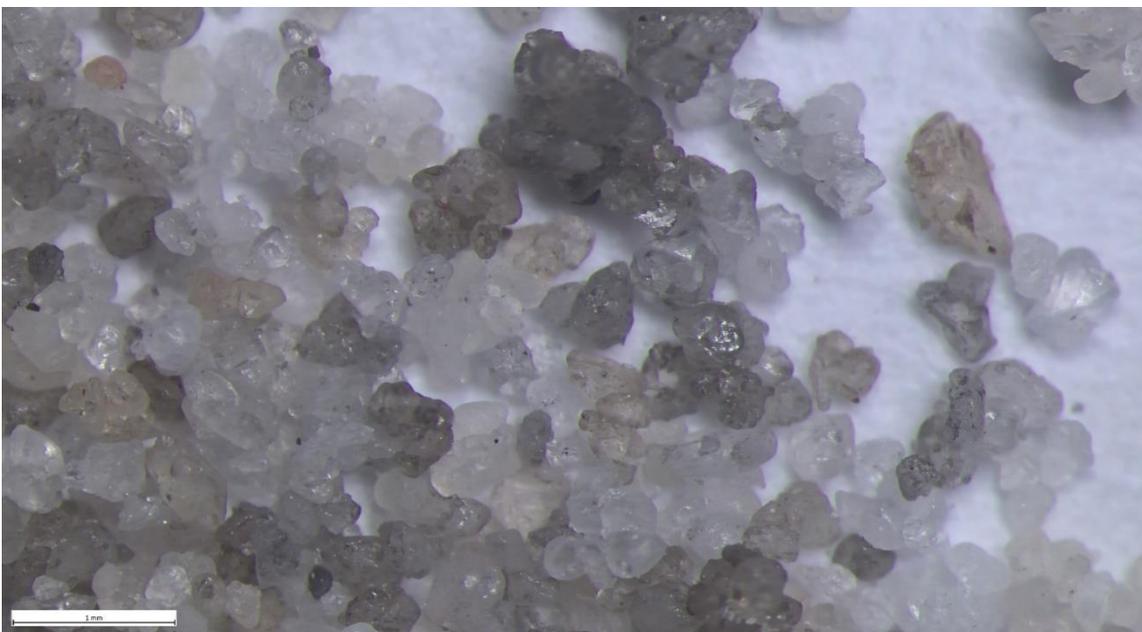
Photo - optical microscope PEAK W37 sand to be treated: overview

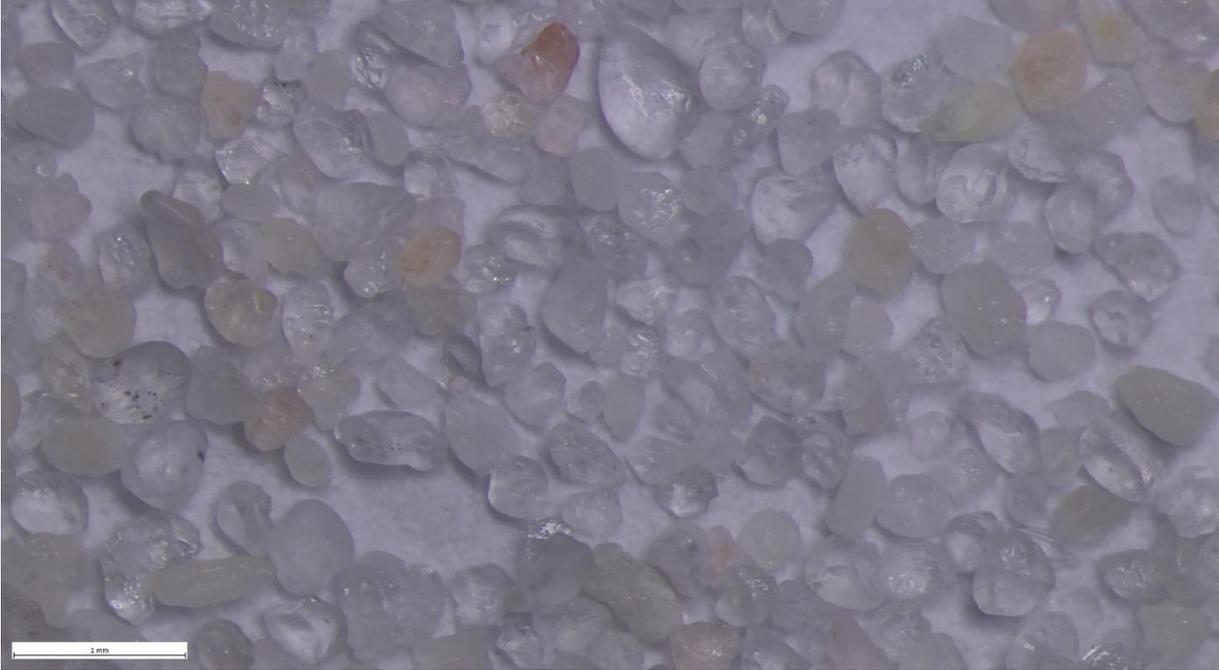
Photo - optical microscope sand new reference BE01: overview

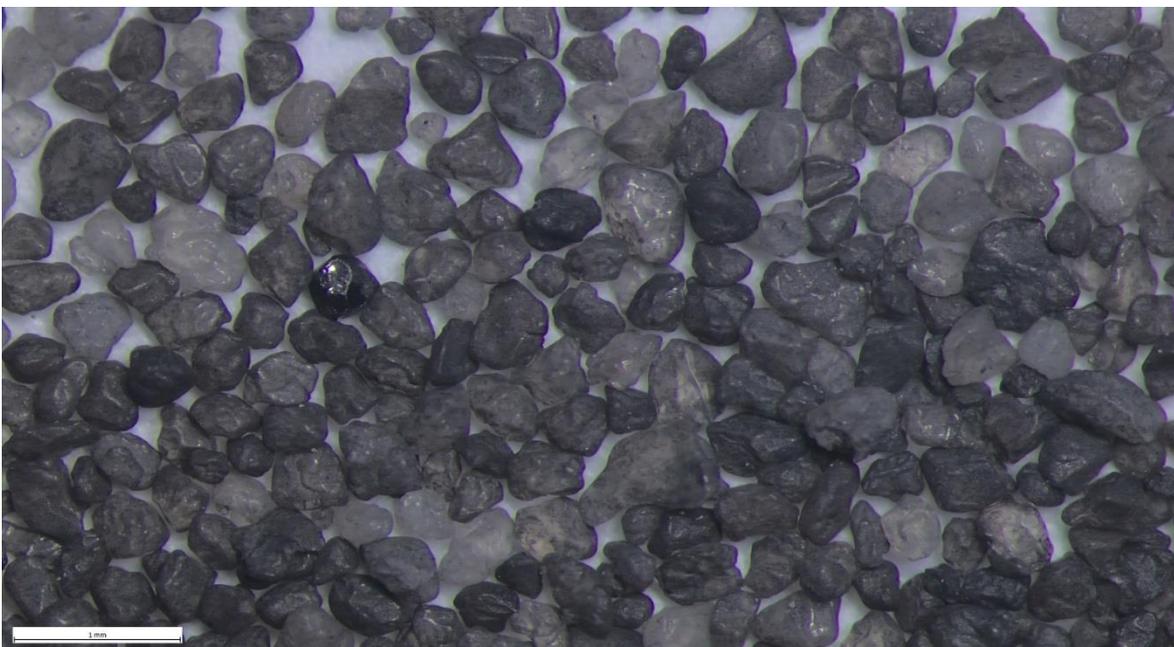
Photo - optical microscope sand CTIF IE mechanically treated: overview

Photo - optical microscope sand INOTEC mechanically treated: overview

Photo - optical microscope Geopol W37-20 mechanically treated sand: overview

Photo - Optical microscope PEAK W37 sand mechanically treated: overview

- Grain breakage for the GEOPOL W37-20 and PEAK W37 sands,
- The production of fines is significant in all cases,
- For all the treated sand samples, conductivity, pH and acid demands are not in conformity with the new sand reference BE01,
- All sand samples are not well cleaned.

- To reduce grain breakage in GEOPOL W37-20 and PEAK W37 sands, the rotation speed of the module and the treatment time should be adjusted (e.g. set to V550T15 or V500T20),
- The 30 minute dedusting time was not sufficient to reduce the fines content,
- The mechanical treatment does not clean the inorganic sand well: the production of fines is high (dry attrition phenomenon), and a large quantity of residual gangue remains stuck to the surface of the grains (temperature rise phenomenon).

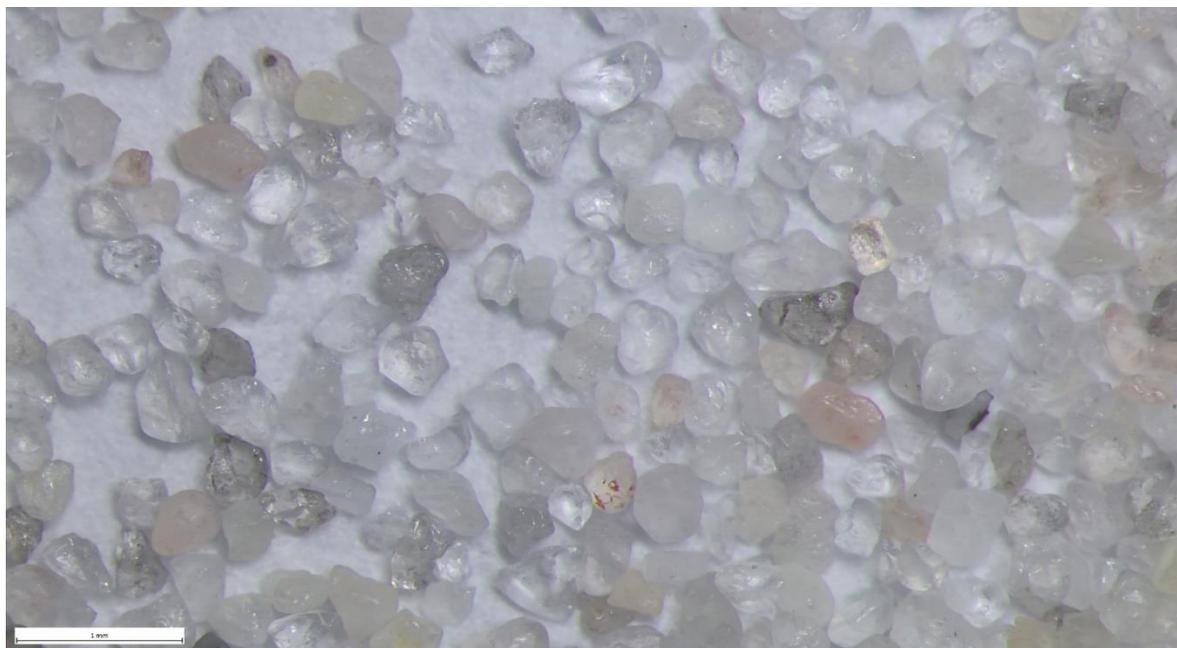
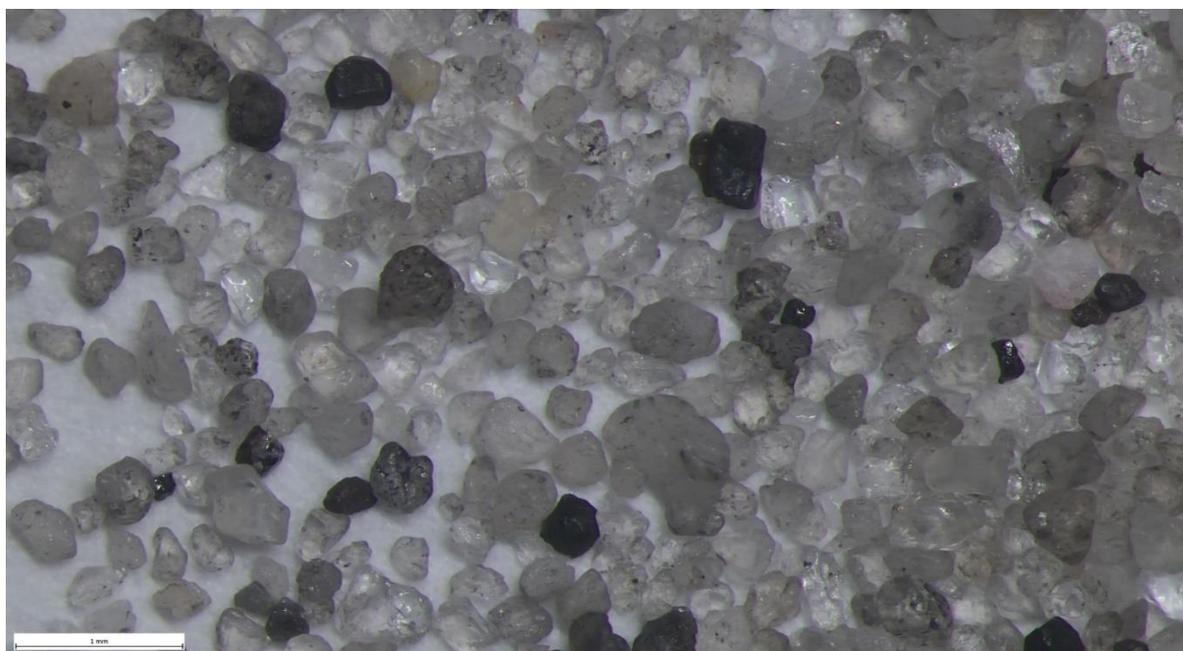
Photo - optical microscope ultrasonically treated CTIF IE sand: overview

Photo - Optical microscope Ultrasonically treated INOTEC sand: overview

Photo - Optical microscope Ultrasonically treated GEOPOL W37-20 sand: overview

Photo - Optical microscope Ultrasonically treated PEAK W37 sand: overview

- No breakage of the sand grains in all cases,
- All the parameters checked are in conformity with the reference sand BE01,
- The sand is well cleaned in all cases,
- Only the INOTEC sand has a slightly high acid demand and a low quantity of clear unstained grains.
- The acid demand of the CTIF IE sand is also a little high.

- The phenomena produced and the effects generated by the treatment are particularly effective in cleaning inorganic sands (with, however, poorer characterisation results of the treated sands, compared to the hydromechanical treatment process),
- The acidic demands that are still somewhat high for INOTEC and CTIF IE sands can be reduced by optimising the settings of the treatment module (treatment time and rinses).

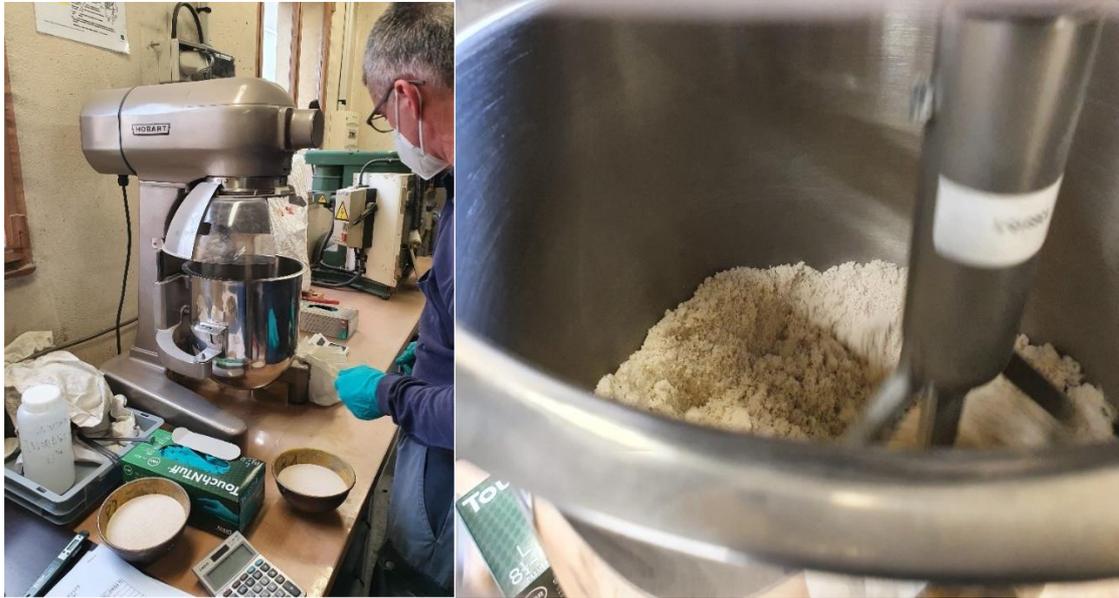
Sand preparation: 2.5% resin + 0.30% hardener

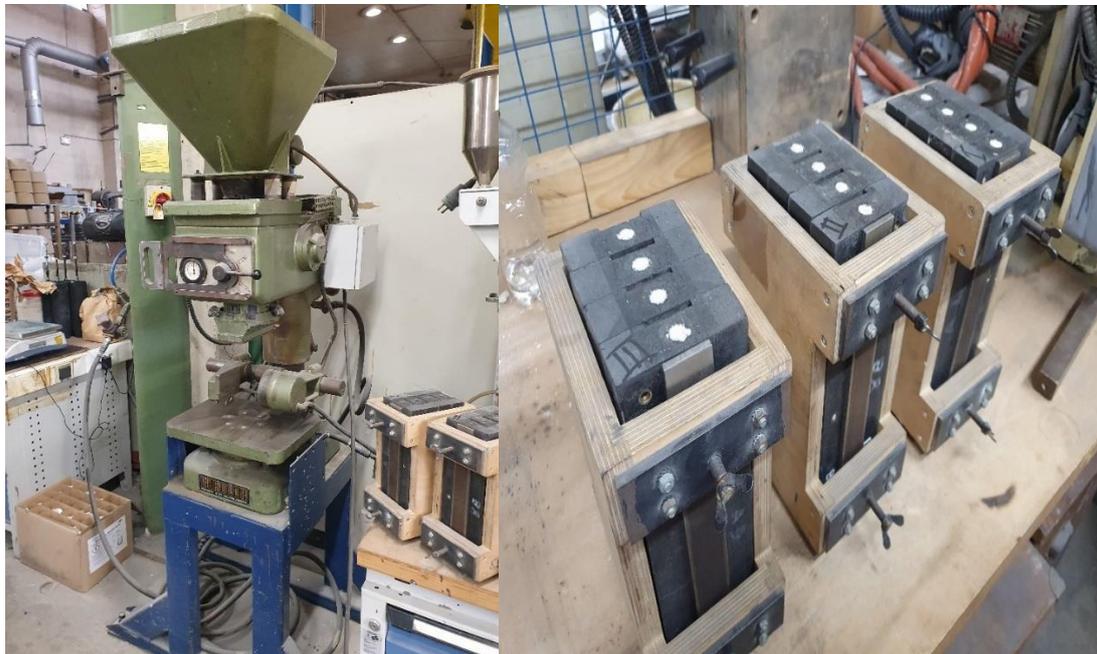
Equipment and tools used to produce cores (standardized test pieces)

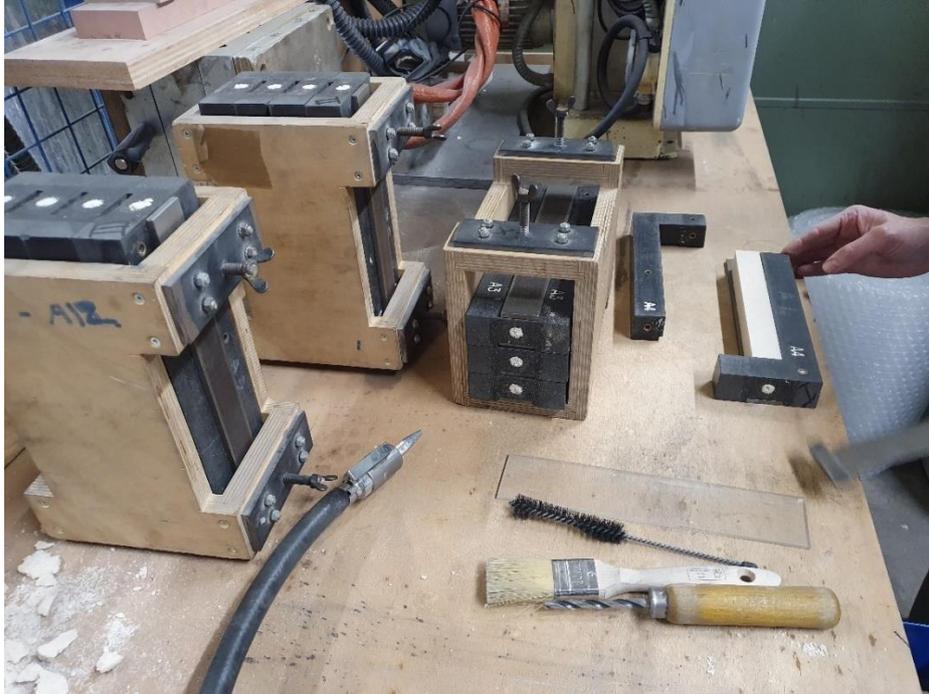
Test pieces removing

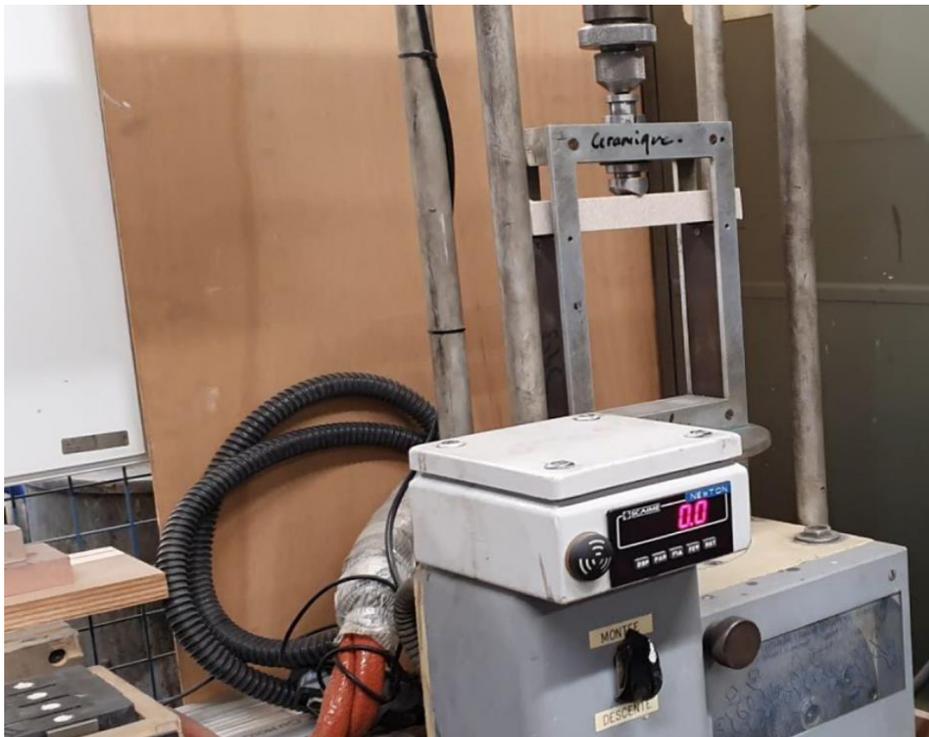
Measurement of flexural strength of test pieces
