Action B4.5 Treatment tests of inorganic sand waste

DeB4.5 Feasibility studies of the reuse of inorganic surplus foundry sand in core making and geo-construction

Action B4.6 Options for reuse of inorganic waste

DeB4.6 Reuse options of inorganic waste sand in geo-construction

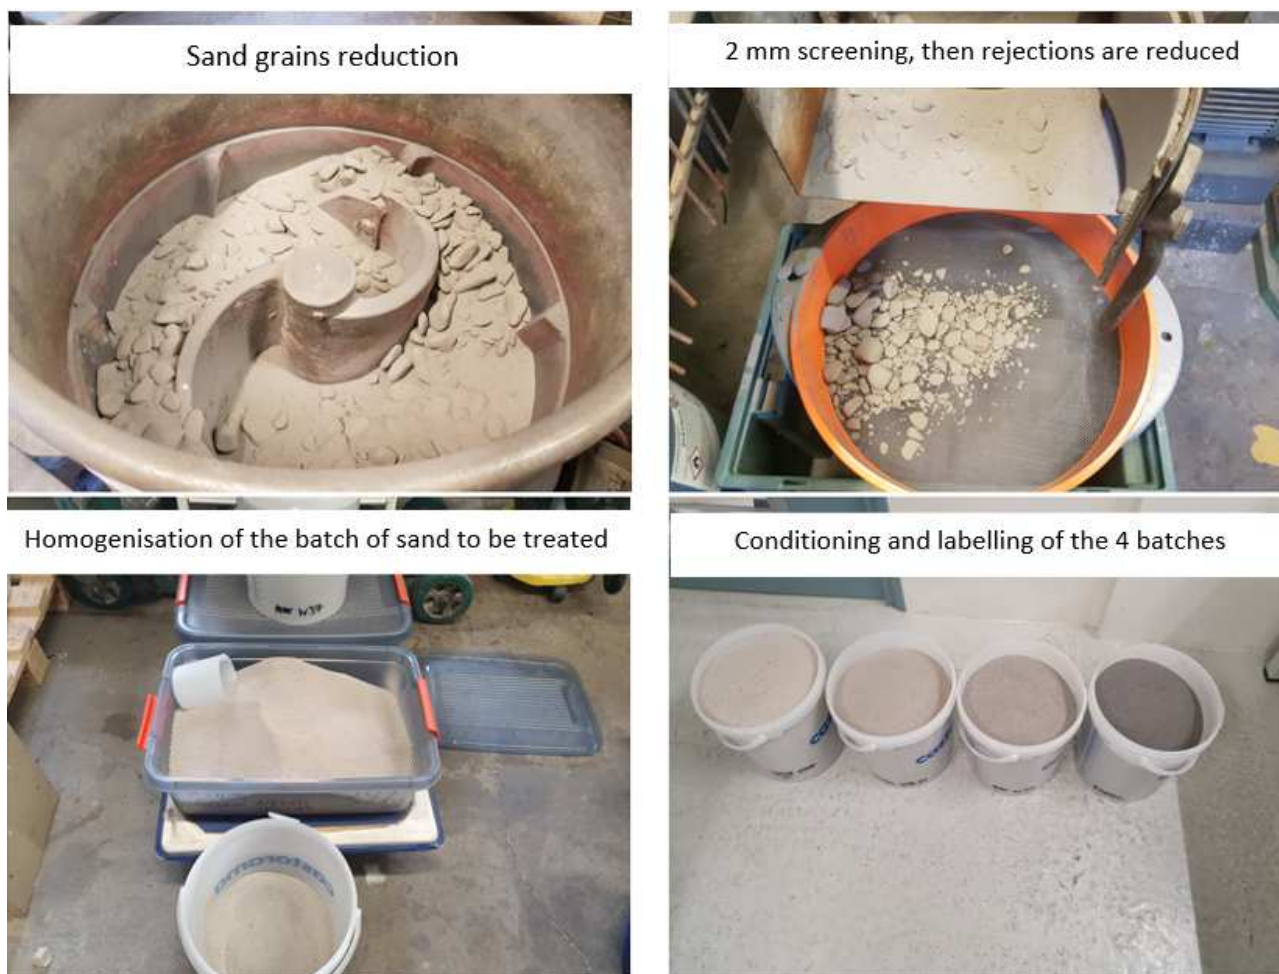
Illustration of the pre-treatment of sand waste to be treated

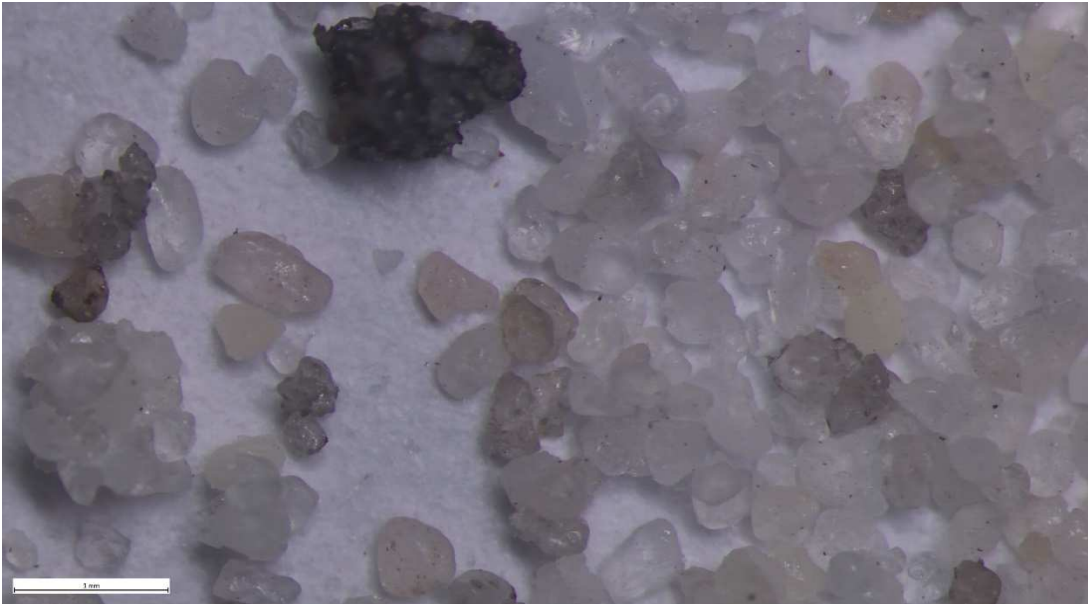
Photo optical microscope CTIF's sand IE to be treated: overview

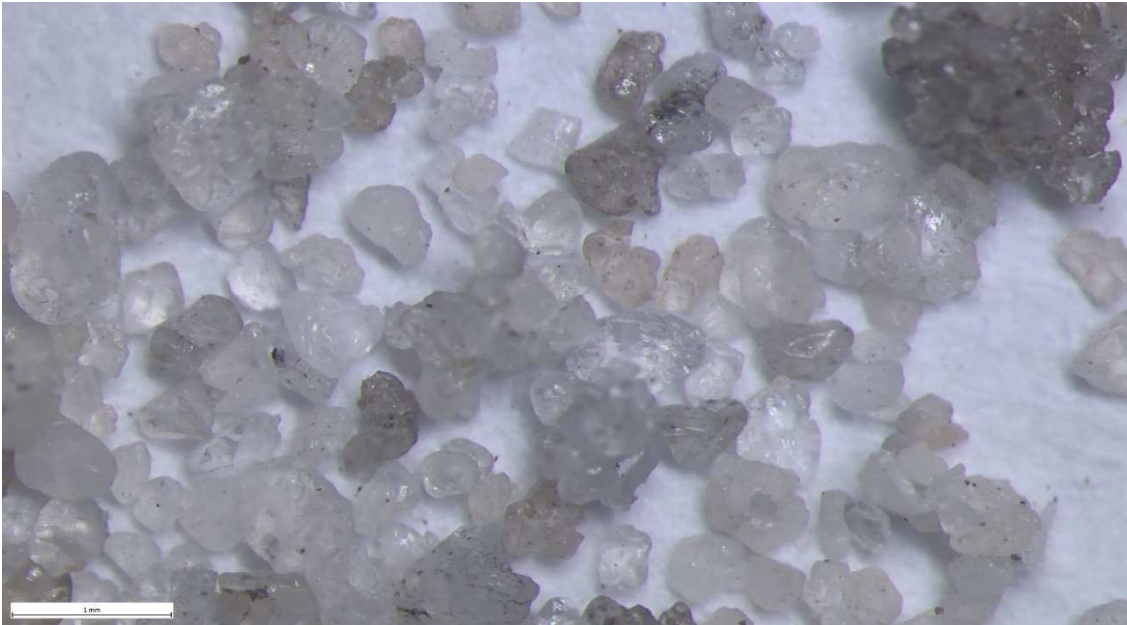
Photo - optical microscope GEOPOL W37-20 sand to be treated: overview

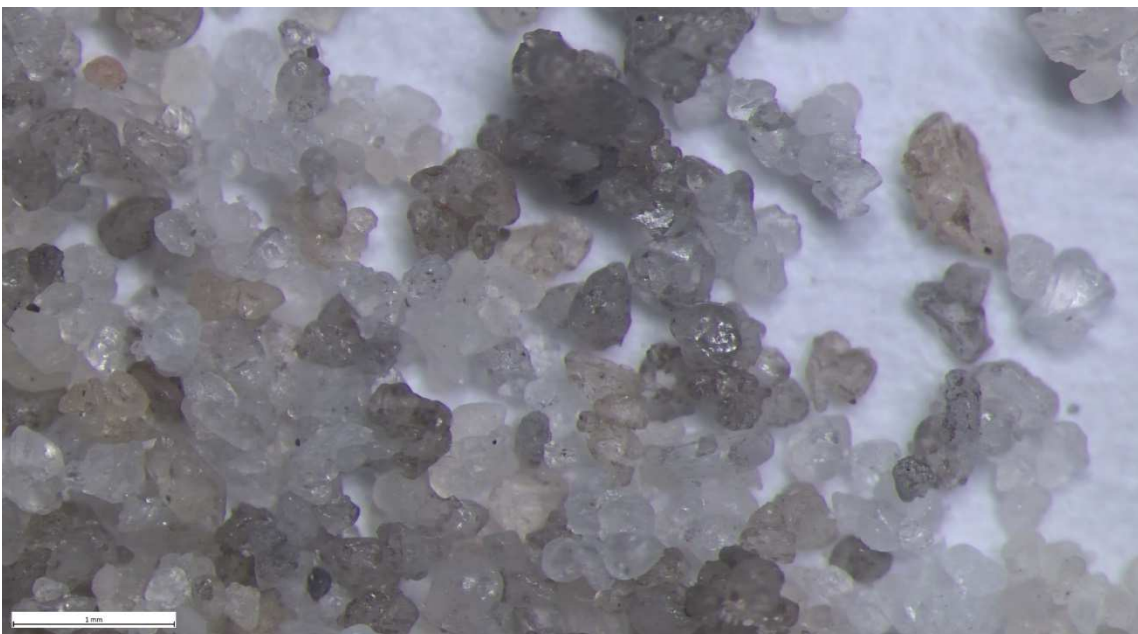
Photo - optical microscope PEAK W37 sand to be treated: overview

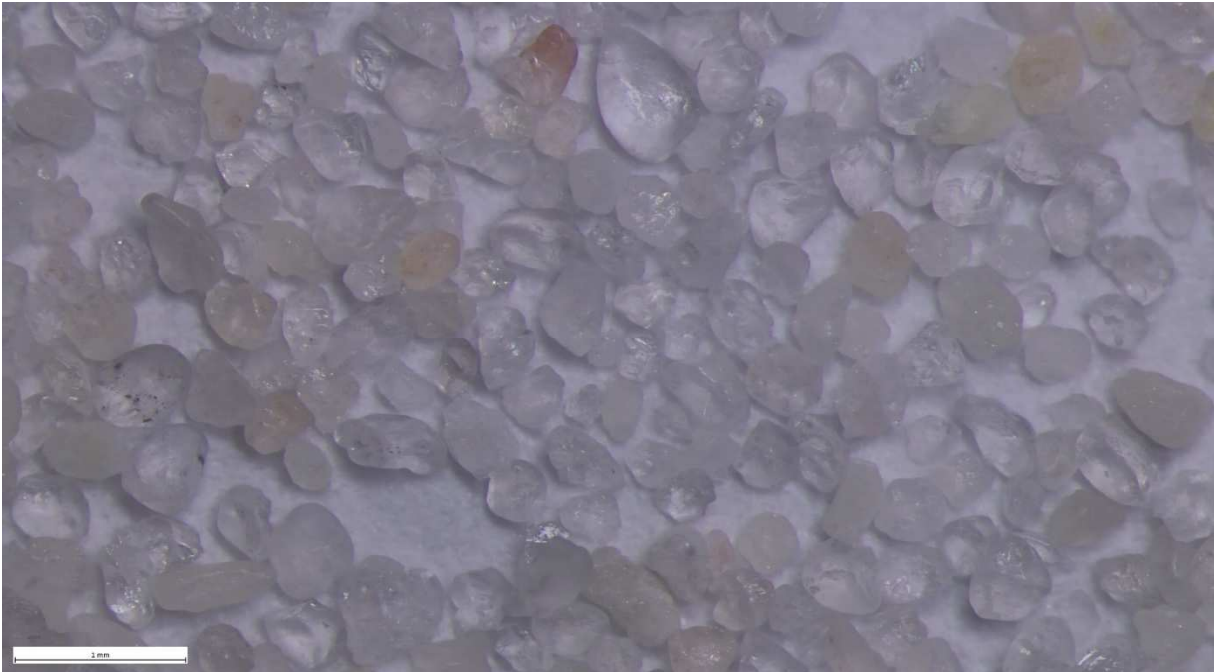
Photo - optical microscope sand new reference BE01: overview

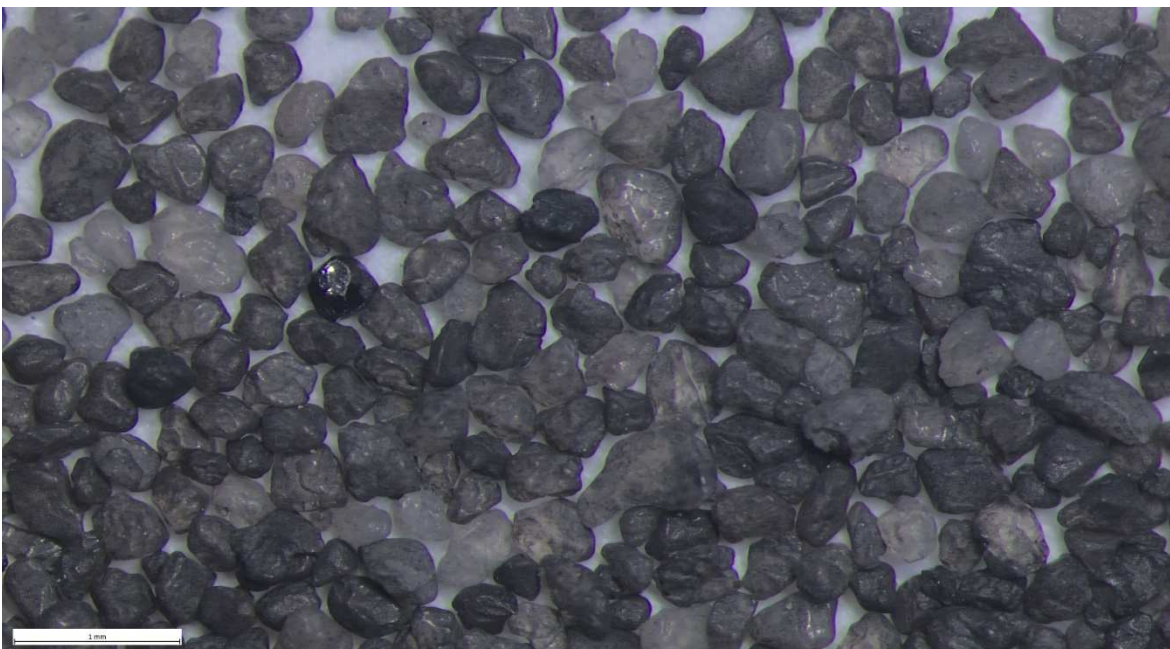
Photo - optical microscope sand INOTEC mechanically treated: overview

Note: after mechanical treatment, no clear unstained grain is found in INOTEC sand: this difference in behaviour compared to other sands is perhaps due to the nature, composition and/or quality of the binder and additives used for this process.

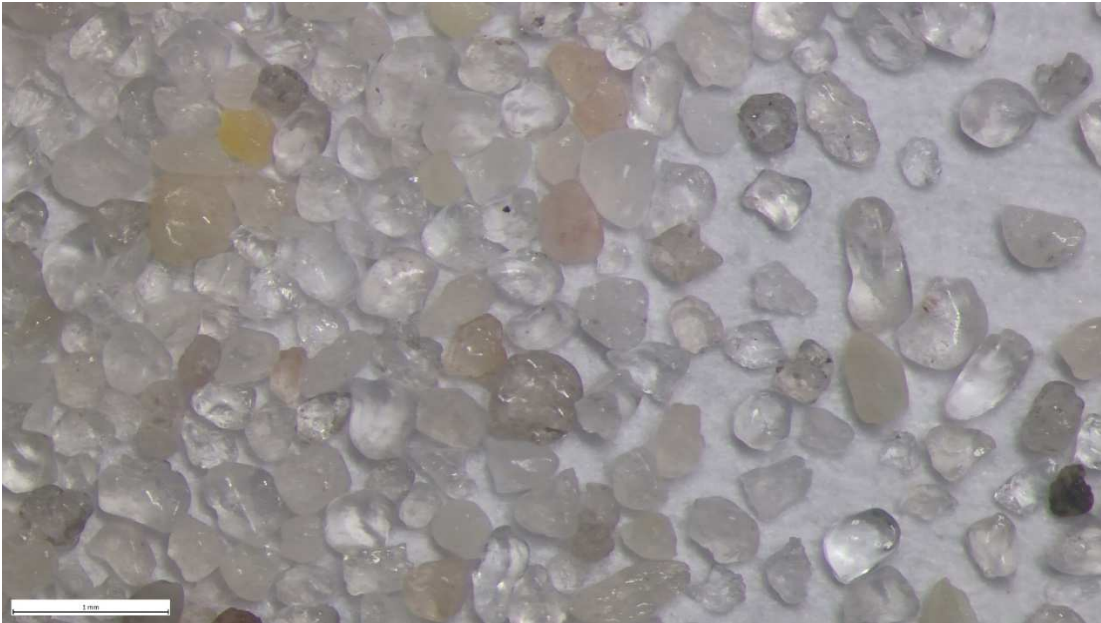
Optical microscope photo of hydromechanically treated CTIF IE sand: overview

- No breakage of the sand grains in all cases,
- All the parameters checked are in conformity with the reference sand BE01,
- The sand is well cleaned in all cases,
- Only the INOTEC sand has a slightly higher acid demand.

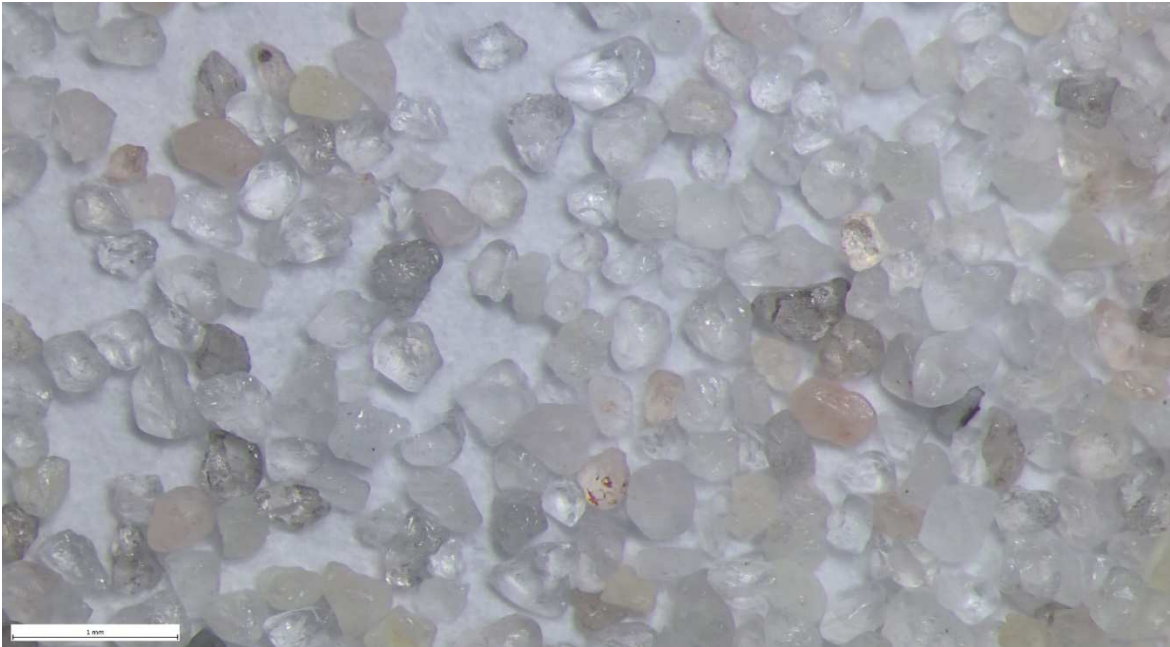
Photo - optical microscope ultrasonically treated CTIF IE sand: overview

- No breakage of the sand grains in all cases,
- All the parameters checked are in conformity with the reference sand BE01,
- The sand is well cleaned in all cases,
- Only the INOTEC sand has a slightly high acid demand and a low quantity of clear unstained grains.
- The acid demand of the CTIF IE sand is also a little high.

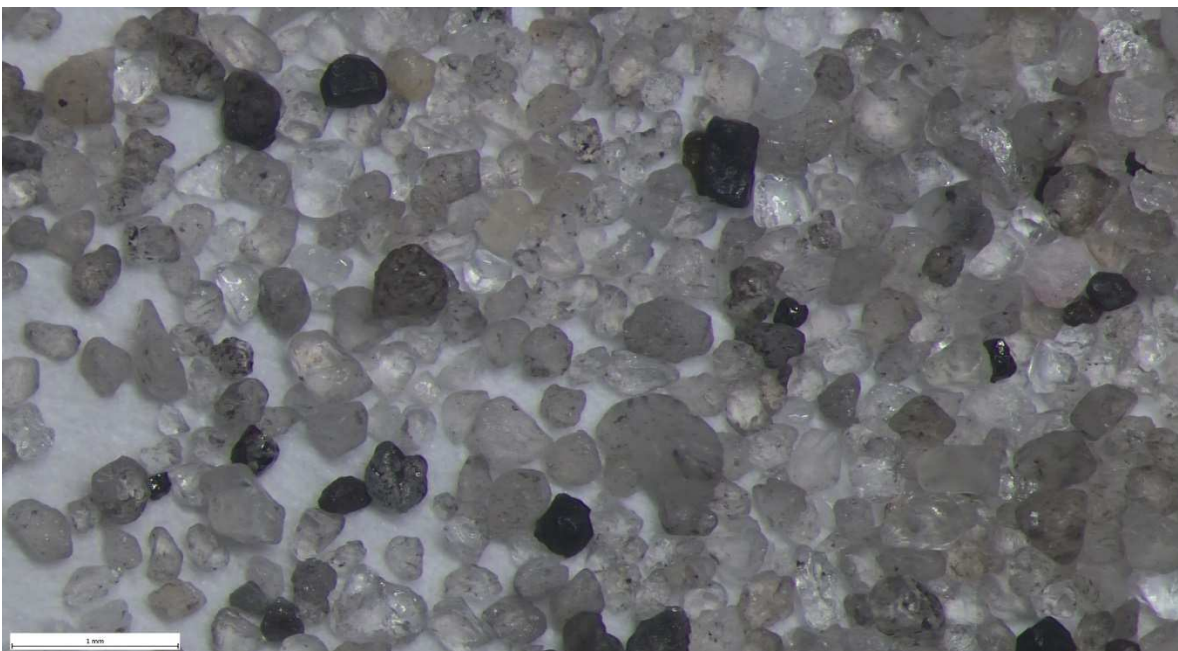
Photo - Optical microscope Ultrasonically treated INOTEC sand: overview

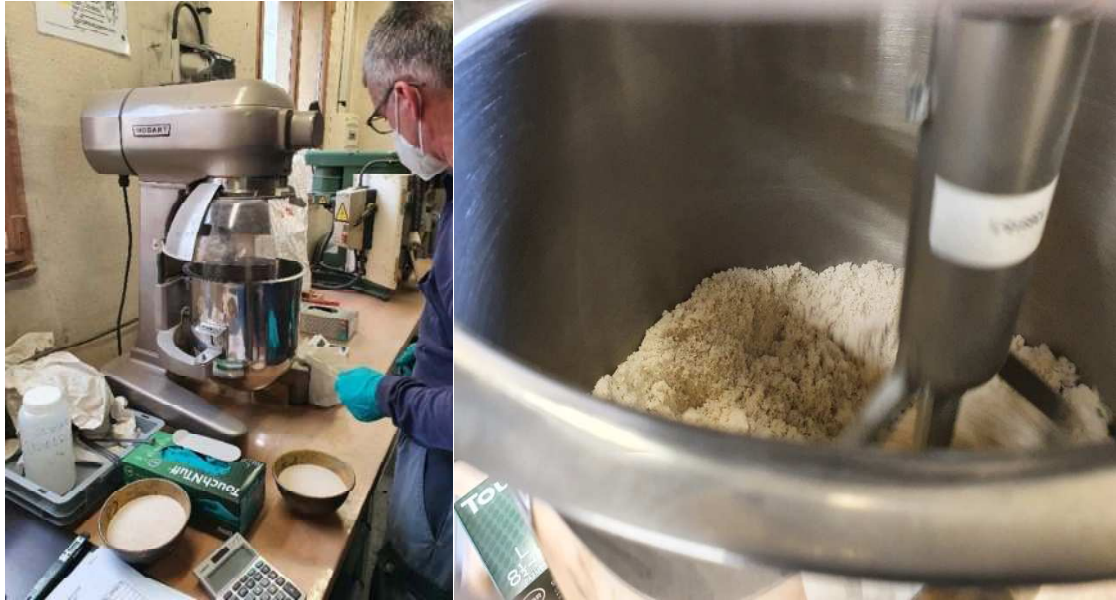
Sand preparation: 2.5% resin + 0.30% hardener

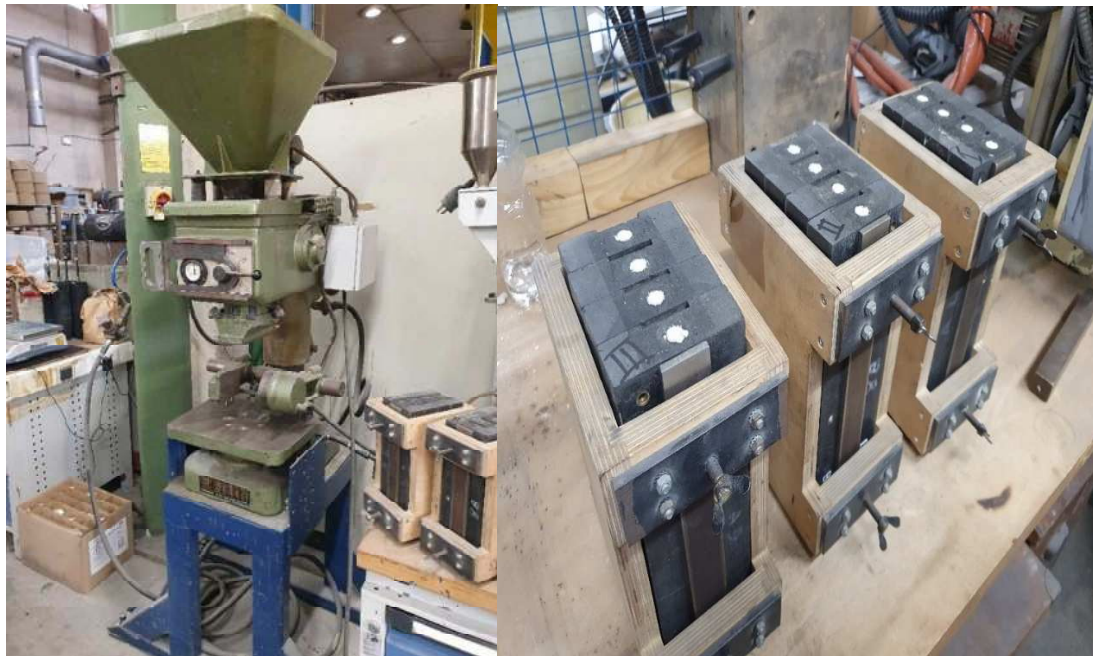
Equipment and tools used to produce cores (standardized test pieces)

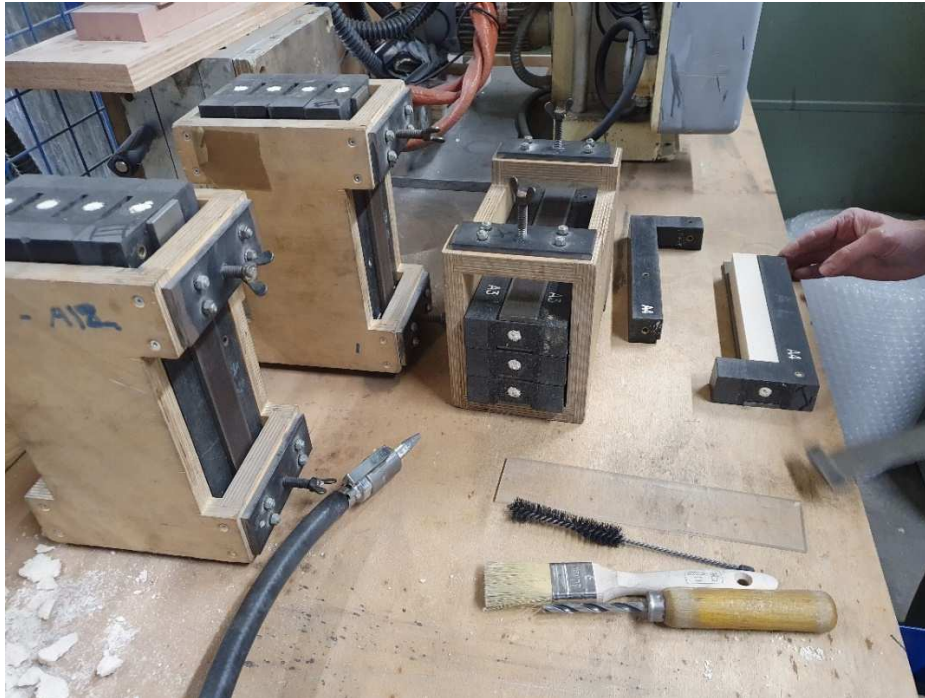
Test pieces removing

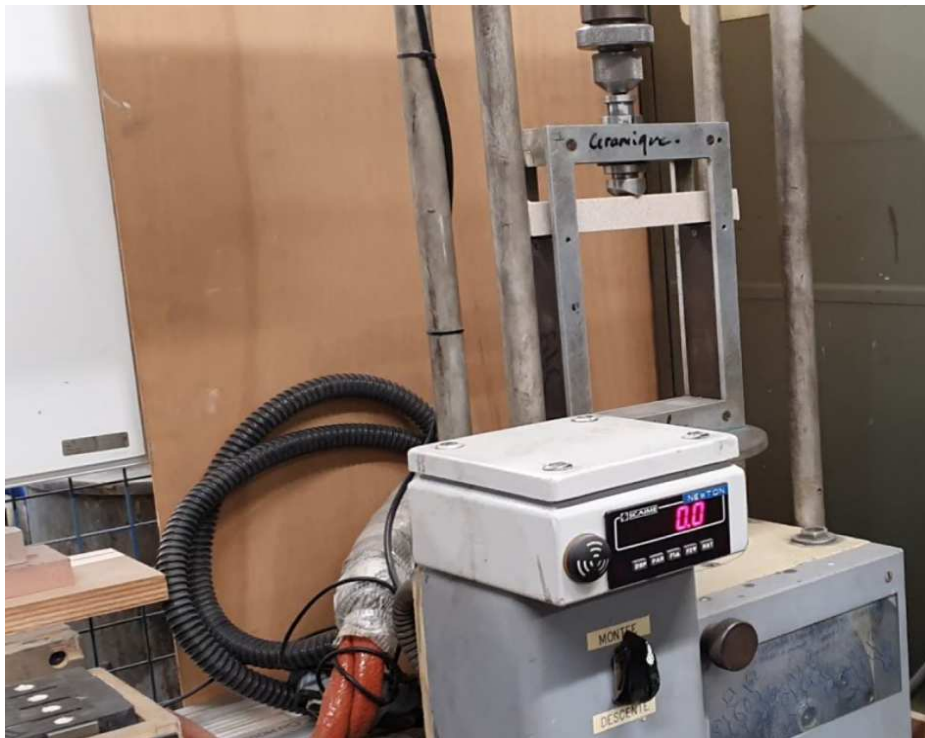
Measurement of flexural strength of test pieces
